Percutaneous Management of Acquired Right Ventricular Outflow Tract Obstruction due to Giant Coronary Vein Graft Aneurysm

To cite this article: Matthew J. Daniels, James D. Newton, Andrew D. Kelion, Mario Petrou & Oliver J. Ormerod (2019) Percutaneous Management of Acquired Right Ventricular Outflow Tract Obstruction due to Giant Coronary Vein Graft Aneurysm, *Structural Heart*, 3:1, 81-82, DOI: [10.1080/24748706.2018.1535206](https://doi.org/10.1080/24748706.2018.1535206)

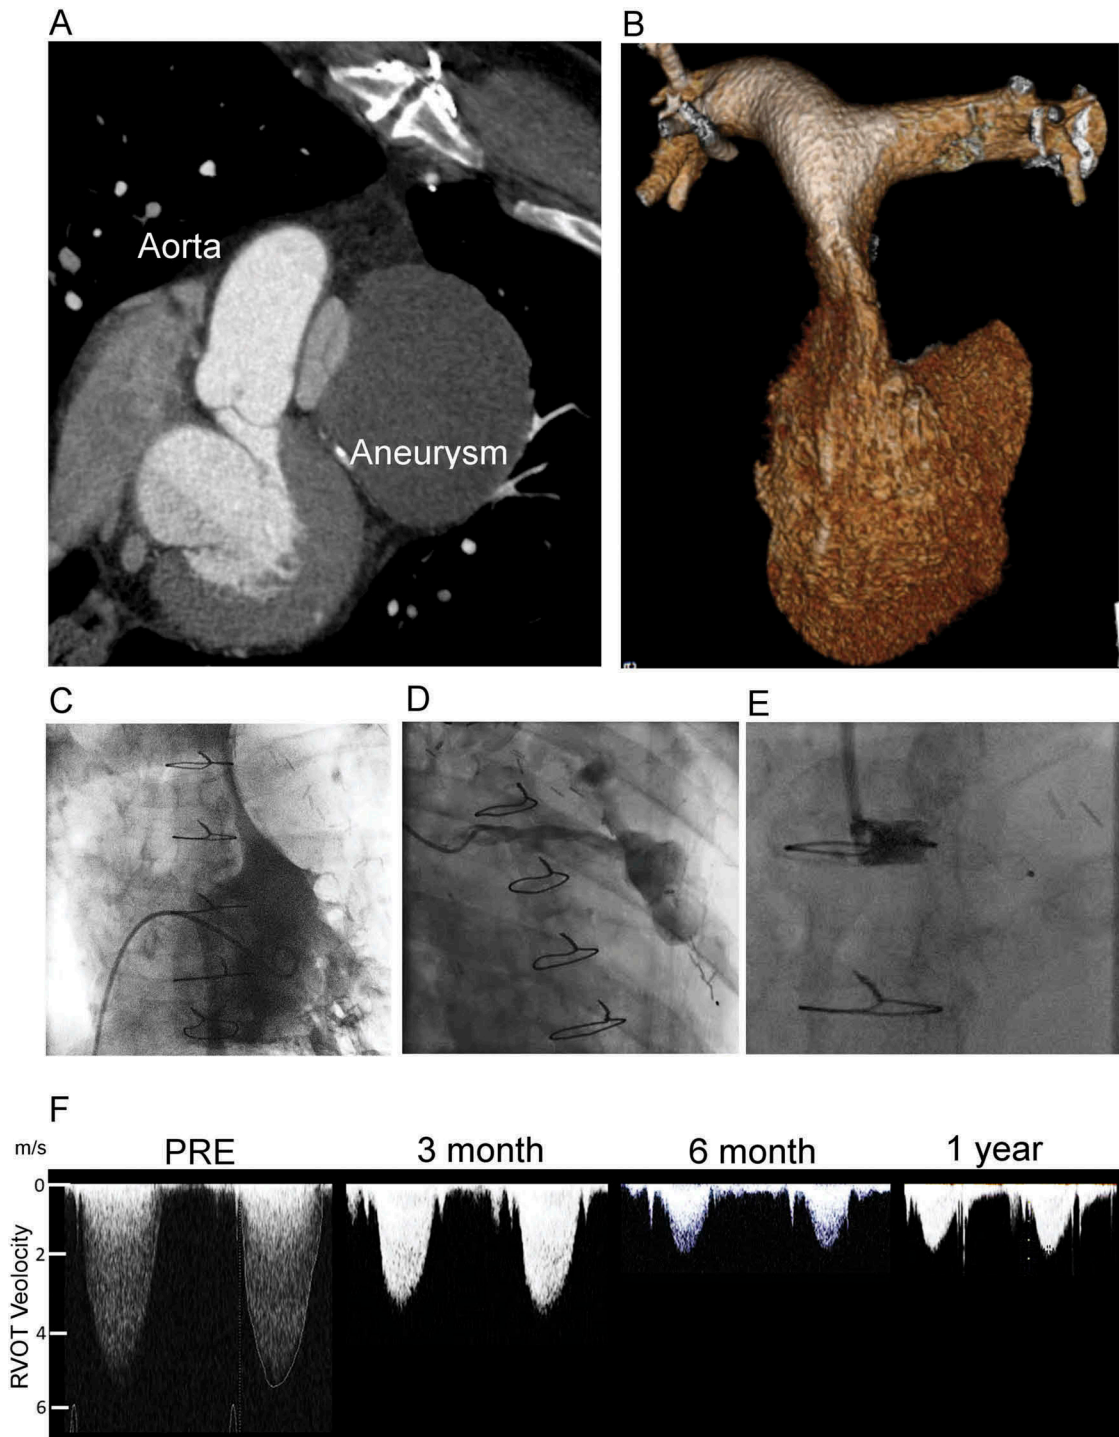
Figure 1. Acquired right ventricular outflow tract (RVOT) obstruction due to coronary graft aneurysm treated by percutaneous graft occlusion. (A) 2D multidetector computed tomography (MDCT) showing compression of the pulmonary valve between the graft aneurysm and the native aorta. (B) 3D MDCT reconstruction of the RV and pulmonary arteries showing the slit-like appearance of the main pulmonary artery. (C) Right ventriculography shows a minimum dimension of 2.2 mm, with an invasive pressure of 83 mmHg. (D) Graft angiography demonstrates the large aneurysm and feeding vessel. (E) An 8-mm AVPII device was used to occlude the graft with the expectation that thrombus would form and ultimately resorb. (F) Serial non-invasive Doppler assessments of the RVOT velocity show progressive and then stable reduction from 5.1 m/s at presentation to 1.7 m/s in follow up. RV dimensions, and hypertrophy normalize over this period. The patient was well and able to return to work at 6 months.

A 56-year-old fireman previously revascularized by coronary artery bypass presented unable to work 9 years following index surgery. Investigations revealed extrinsic compression of the right ventricular outflow tract between a coronary vein graft aneurysm and the ascending aorta (Figure 1A,B). Invasive systolic right ventricular pressure was elevated (83 mmHg peak pressure), with dynamic outflow tract obstruction (Figure 1C, Supplemental Video 1). Following heart team discussion in the absence of distal run off from the graft aneurysm the patient was offered transcatheter closure of the feeding vessel. The vein graft was cannulated with a JR4 catheter, sized (Figure 1D), and an 0.035" Terumo wire used to advance distally to position an Amplatzer superstiff wire in the aneurysm. A 5F Amplatzer Torquevue 2 delivery system was used to deploy an 8 mm AVPII device within the proximal part of the vein graft. Non-invasive follow-up over the next 12 months showed resolution of acquired RVOT obstruction. The patient returned to work at 6 months
